## **ANZCDACC Product Defect Correction Notice 17<sup>th</sup> Jan 2019**

**Device:** Programmer Software Update supporting the Micra Transcatheter Pacing System (TPS)

Medtronic 2090 Carelink Programmer, 29901 Encore Programmer, Carelink Network Application software 2491

**TGA Reference:** RC-2019-RN-00079-1

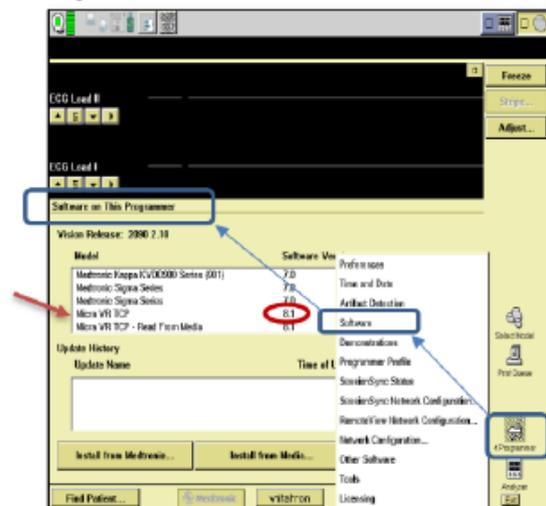
Image 1

Correct software: Micra VR TCP version 8.1 (or higher)

- Select Software (see image 1)
- Scroll through the list of available Software Models in the top selection box until you locate the Micra selection
- Verify the Software Micra VR TCP Version is 8.1

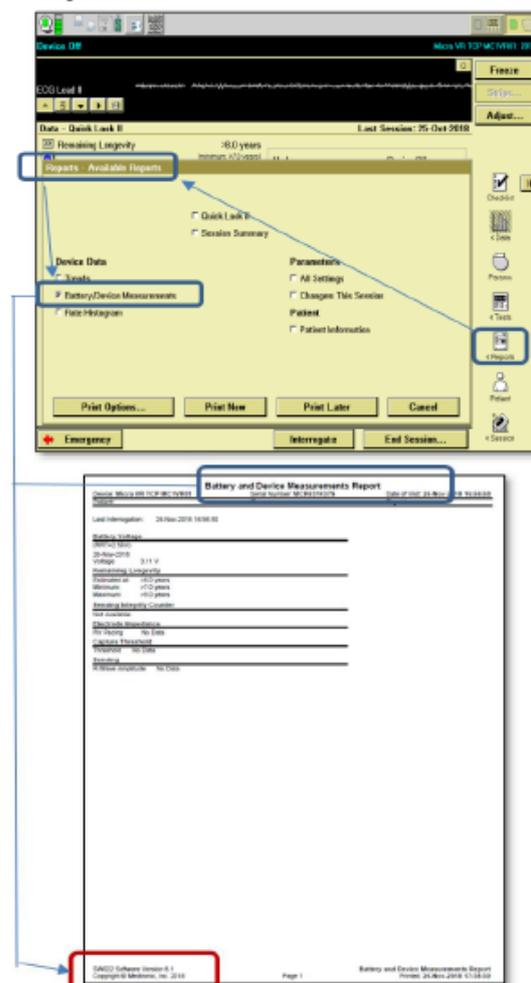
Images 2a and 2b

Any CareLink transmission completed after 17 January 2019 will report the updated remaining longevity estimate. For in-clinic patients who have been interrogated via a programmer, the clinician can view the Battery and Device Measurements Report (Images 2a and 2b) and verify that the Software Application Model ID located in the lower-left corner of the report indicates "SW022 Software Version 8.1".

- Select Reports (see image 2a)
- Select Battery/Device Measurements
- Click Print Now
- Verify the software version printed on the lower left-hand corner is "SW022 Software Version 8.1"
