ANZCDACC Implant Hazard Alert June 2021

Device: Boston Scientific dual chamber INGENIO family pacemakers and Cardiac resynchronisation (CRTPs).

Models: ADVANTIO DR EL (K084, K087), INGENIO DR EL (K184, K187), VITALIO DR EL (K287), INVIVE CRT-P (V182, V183)

TGA Reference: RC-2021-RN-01305-1

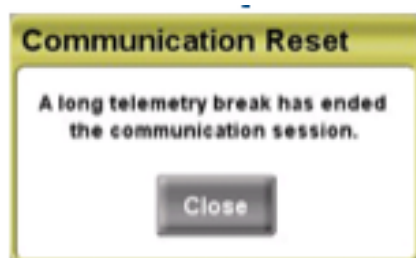
- If the device resets in clinic, the failed telemetry attempts will be displayed as follows in Figure 1. The programmer will automatically try to communicate with the device again when the 'close' button is pressed. After the third system reset within a 48-hour period, the device will immediately enter Safety Mode and display the programmer warning screen illustrated in Figure 2.

Figure 1. Programmer notification that reset has occurred.

3. **Response to reset.** If the programmer displays the notification shown in Figure 1 twice in a row in an affected device, turn the programmer off to allow the clinic to consider and plan for the chance of the device entering Safety Mode. This should include a risk assessment (see point 1) and depending on the result of this may include ensuring external pacing equipment is immediately available or even prompt generator change (see point 5).

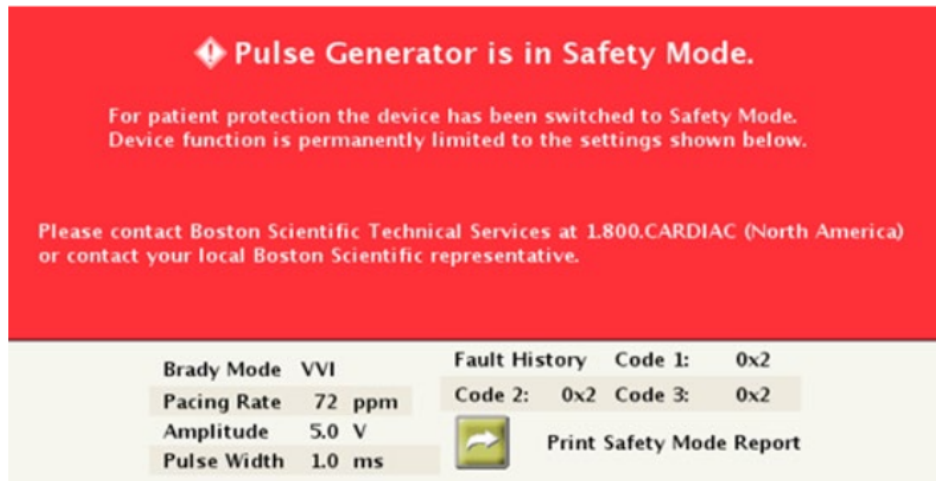
Figure 2. Programmer warning screen for safety mode.

5. **Replacement.** If a device enters Safety Mode, schedule replacement. Boston Scientific and ANZCDACC do not recommend general prophylactic replacement for affected devices. However, for individual patients, factors such as those listed above and shared decision-making may support consideration of early device replacement to mitigate unintended clinical impact(s) due to potential entry into Safety Mode prior to the Explant indicator. In these cases, the following guidance should be considered:
