Australia New Zealand Cardiac Device Advisory and Complication Committee (ANZCDACC)

Product Hazard Alert December 2023

Update to high battery impedance alert for
Boston Scientific INGENIO™ / VITALIO™ /
ADVANTIO™ extended life pacemakers and
INLIVEN™ / INVIVE™ CRT pacemakers

RC-2023-RN-01027-1

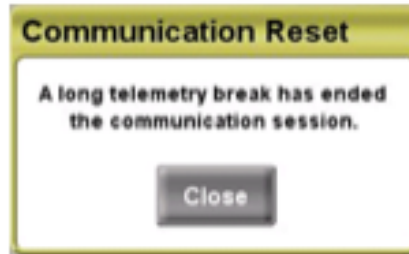
If the device resets in clinic, the failed telemetry attempts will be displayed as follows in Figure 1. The programmer will automatically try to communicate with the device again when the 'close' button is pressed. After the third system reset within a 48-hour period, the device will immediately enter Safety Mode.

Figure 1. Programmer notification that reset has occurred.

- a. If the programmer displays the notification shown in Figure 1 twice in a row in an affected device, turn the programmer off to allow the clinic to consider and plan for the chance of the device entering Safety Mode. This should include a risk assessment (see point 1) and depending on the result of this may include ensuring external pacing equipment is immediately available or even prompt generator change.
